HYDROGEOLOGICAL INVESTIGATION

26-38 Hounslow Avenue, Toronto, Ontario, M2N 2A8

BIGC-GEO-154H

September 21, 2023 (Revision 4)

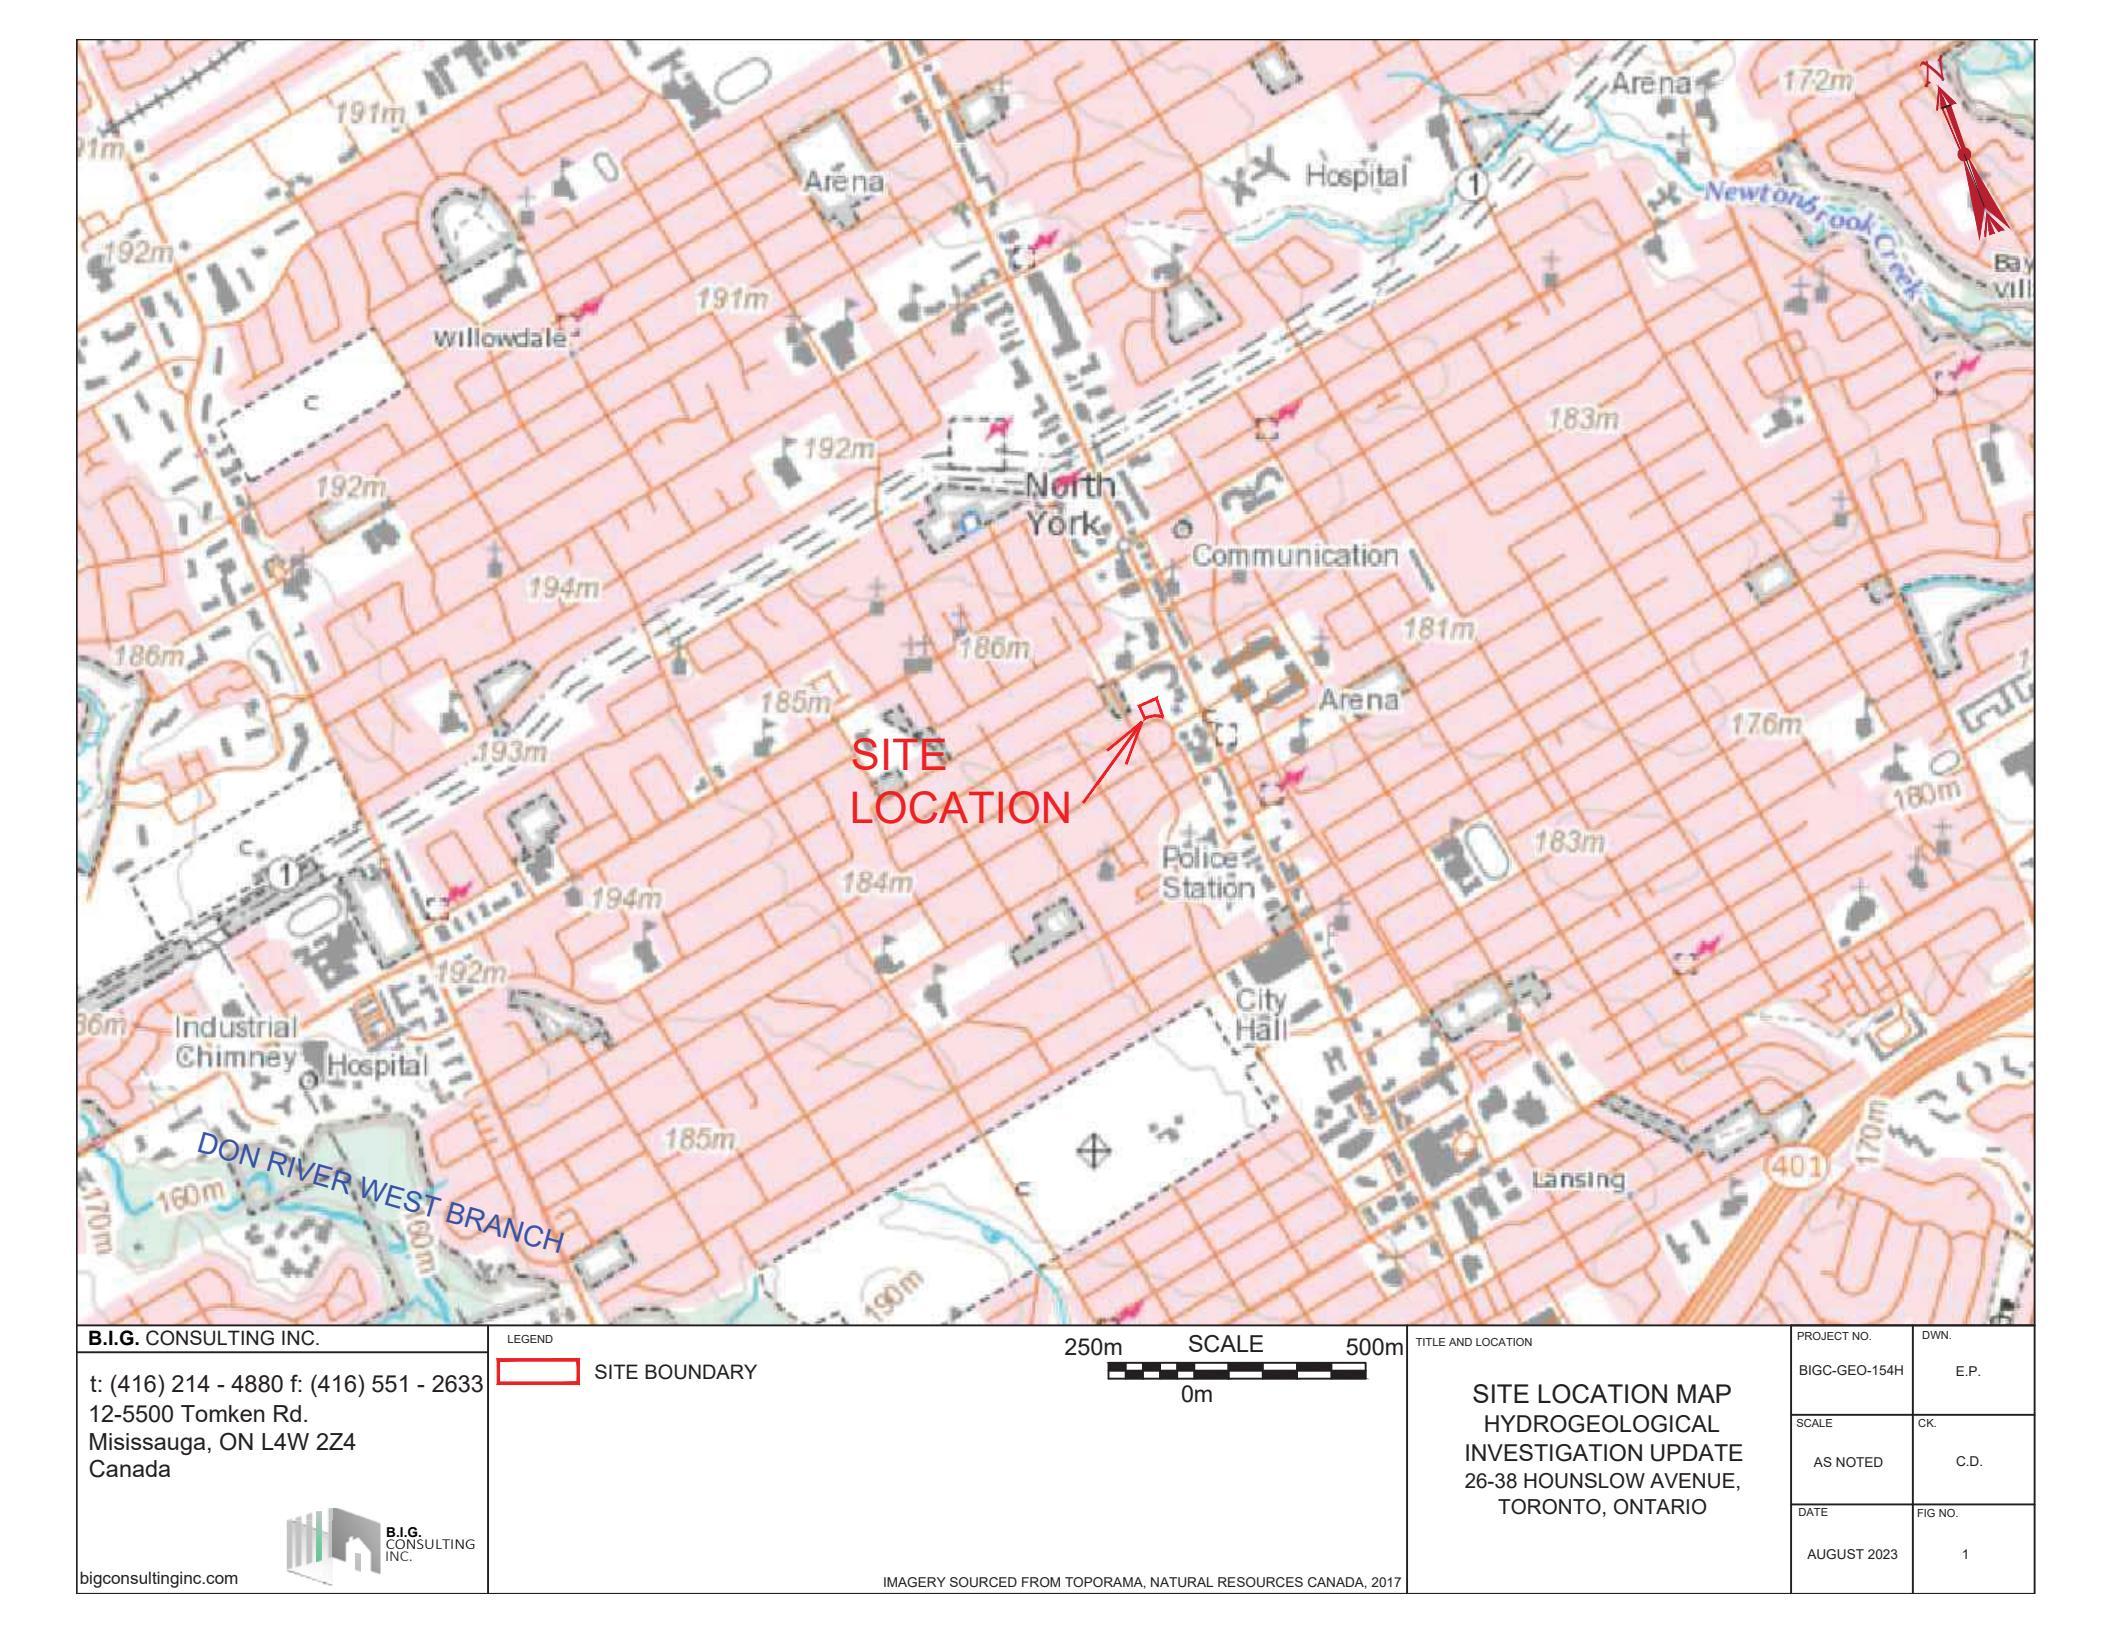
The Site is located north of Hounslow Avenue and east of Beecroft Road, in Toronto, Ontario, as shown on Figure 1. The Site measures approximately 2,380 m² in size. The Site is currently occupied by four (4) residential buildings. The areas surrounding the residential buildings are covered with asphalt and landscaping. A Site Location Plan is provided in Figure 1.

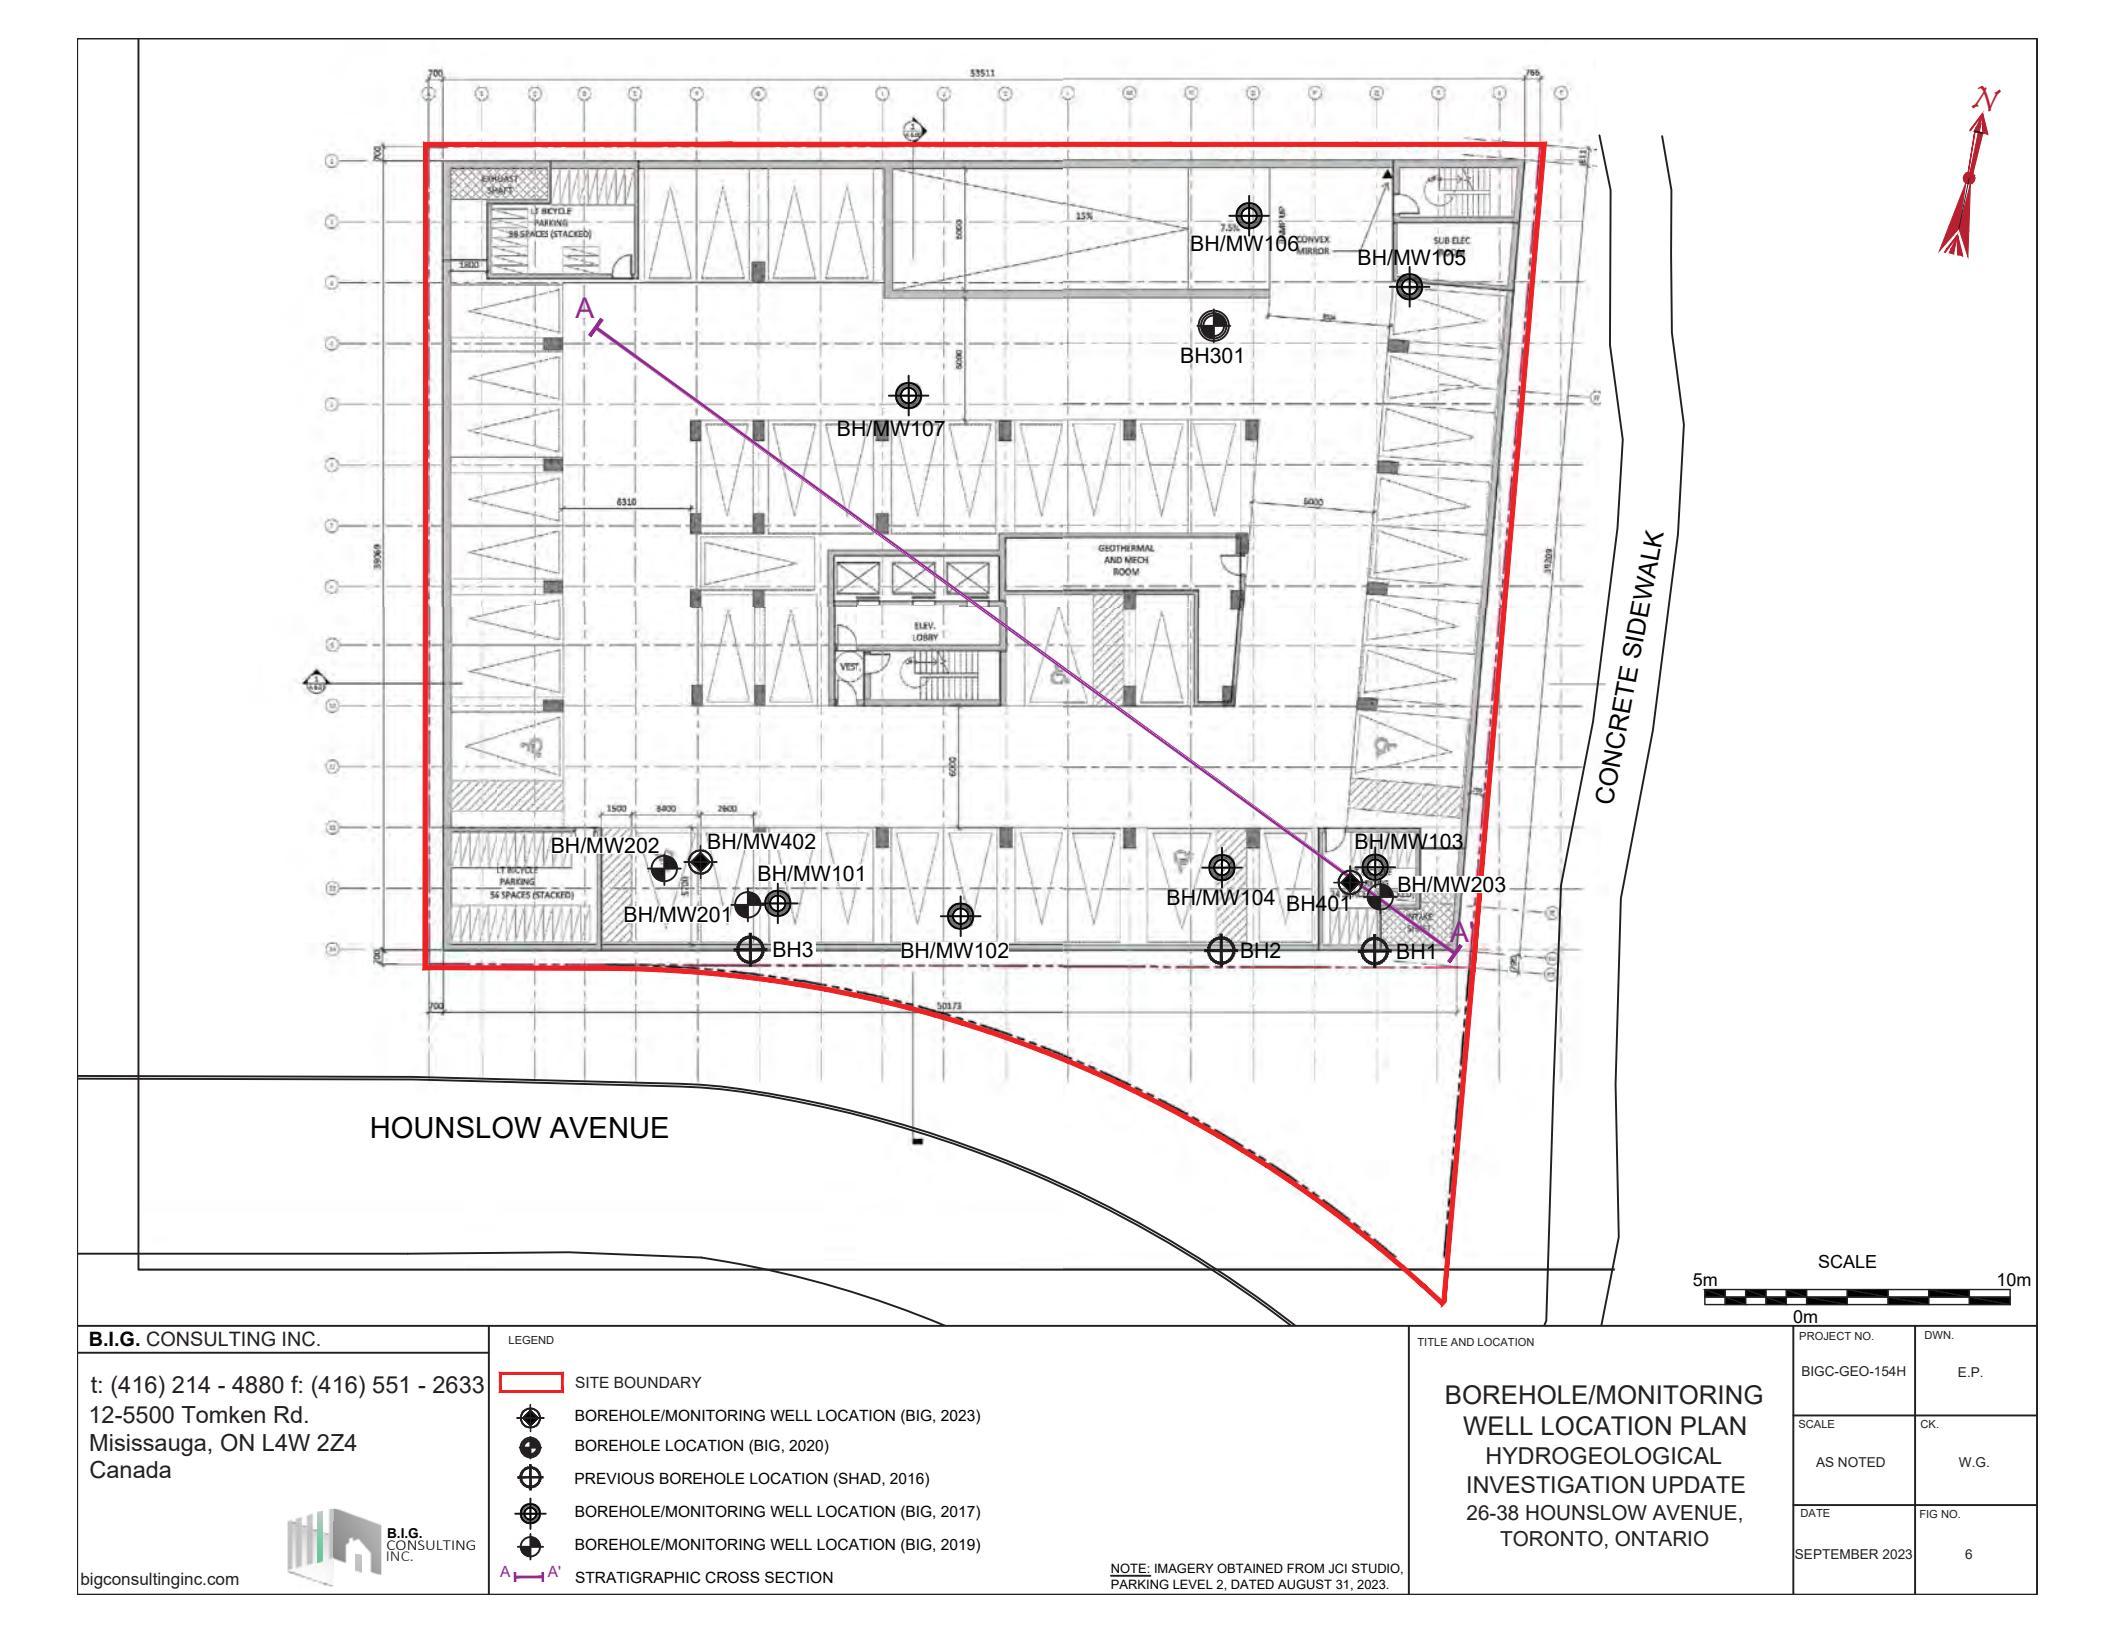
The borehole locations are shown on Figure 6 and detailed subsurface conditions are presented on the borehole logs in Appendix A. The following table is provided in addition to the borehole descriptions to provide a general summary of the soil conditions. The soil descriptions are predominately based on BIG's investigation, however, where applicable soil conditions encountered during previous investigation by others are included. The soil boundaries indicated on the borehole logs and discussed herein are inferred from the visual observations and auger resistance and should not be regarded as exact planes of geological change.

The soil conditions encountered at the borehole locations are summarized below. A stratigraphic crosssection across the property as aligned on Figure 6 is included as Figure 7.

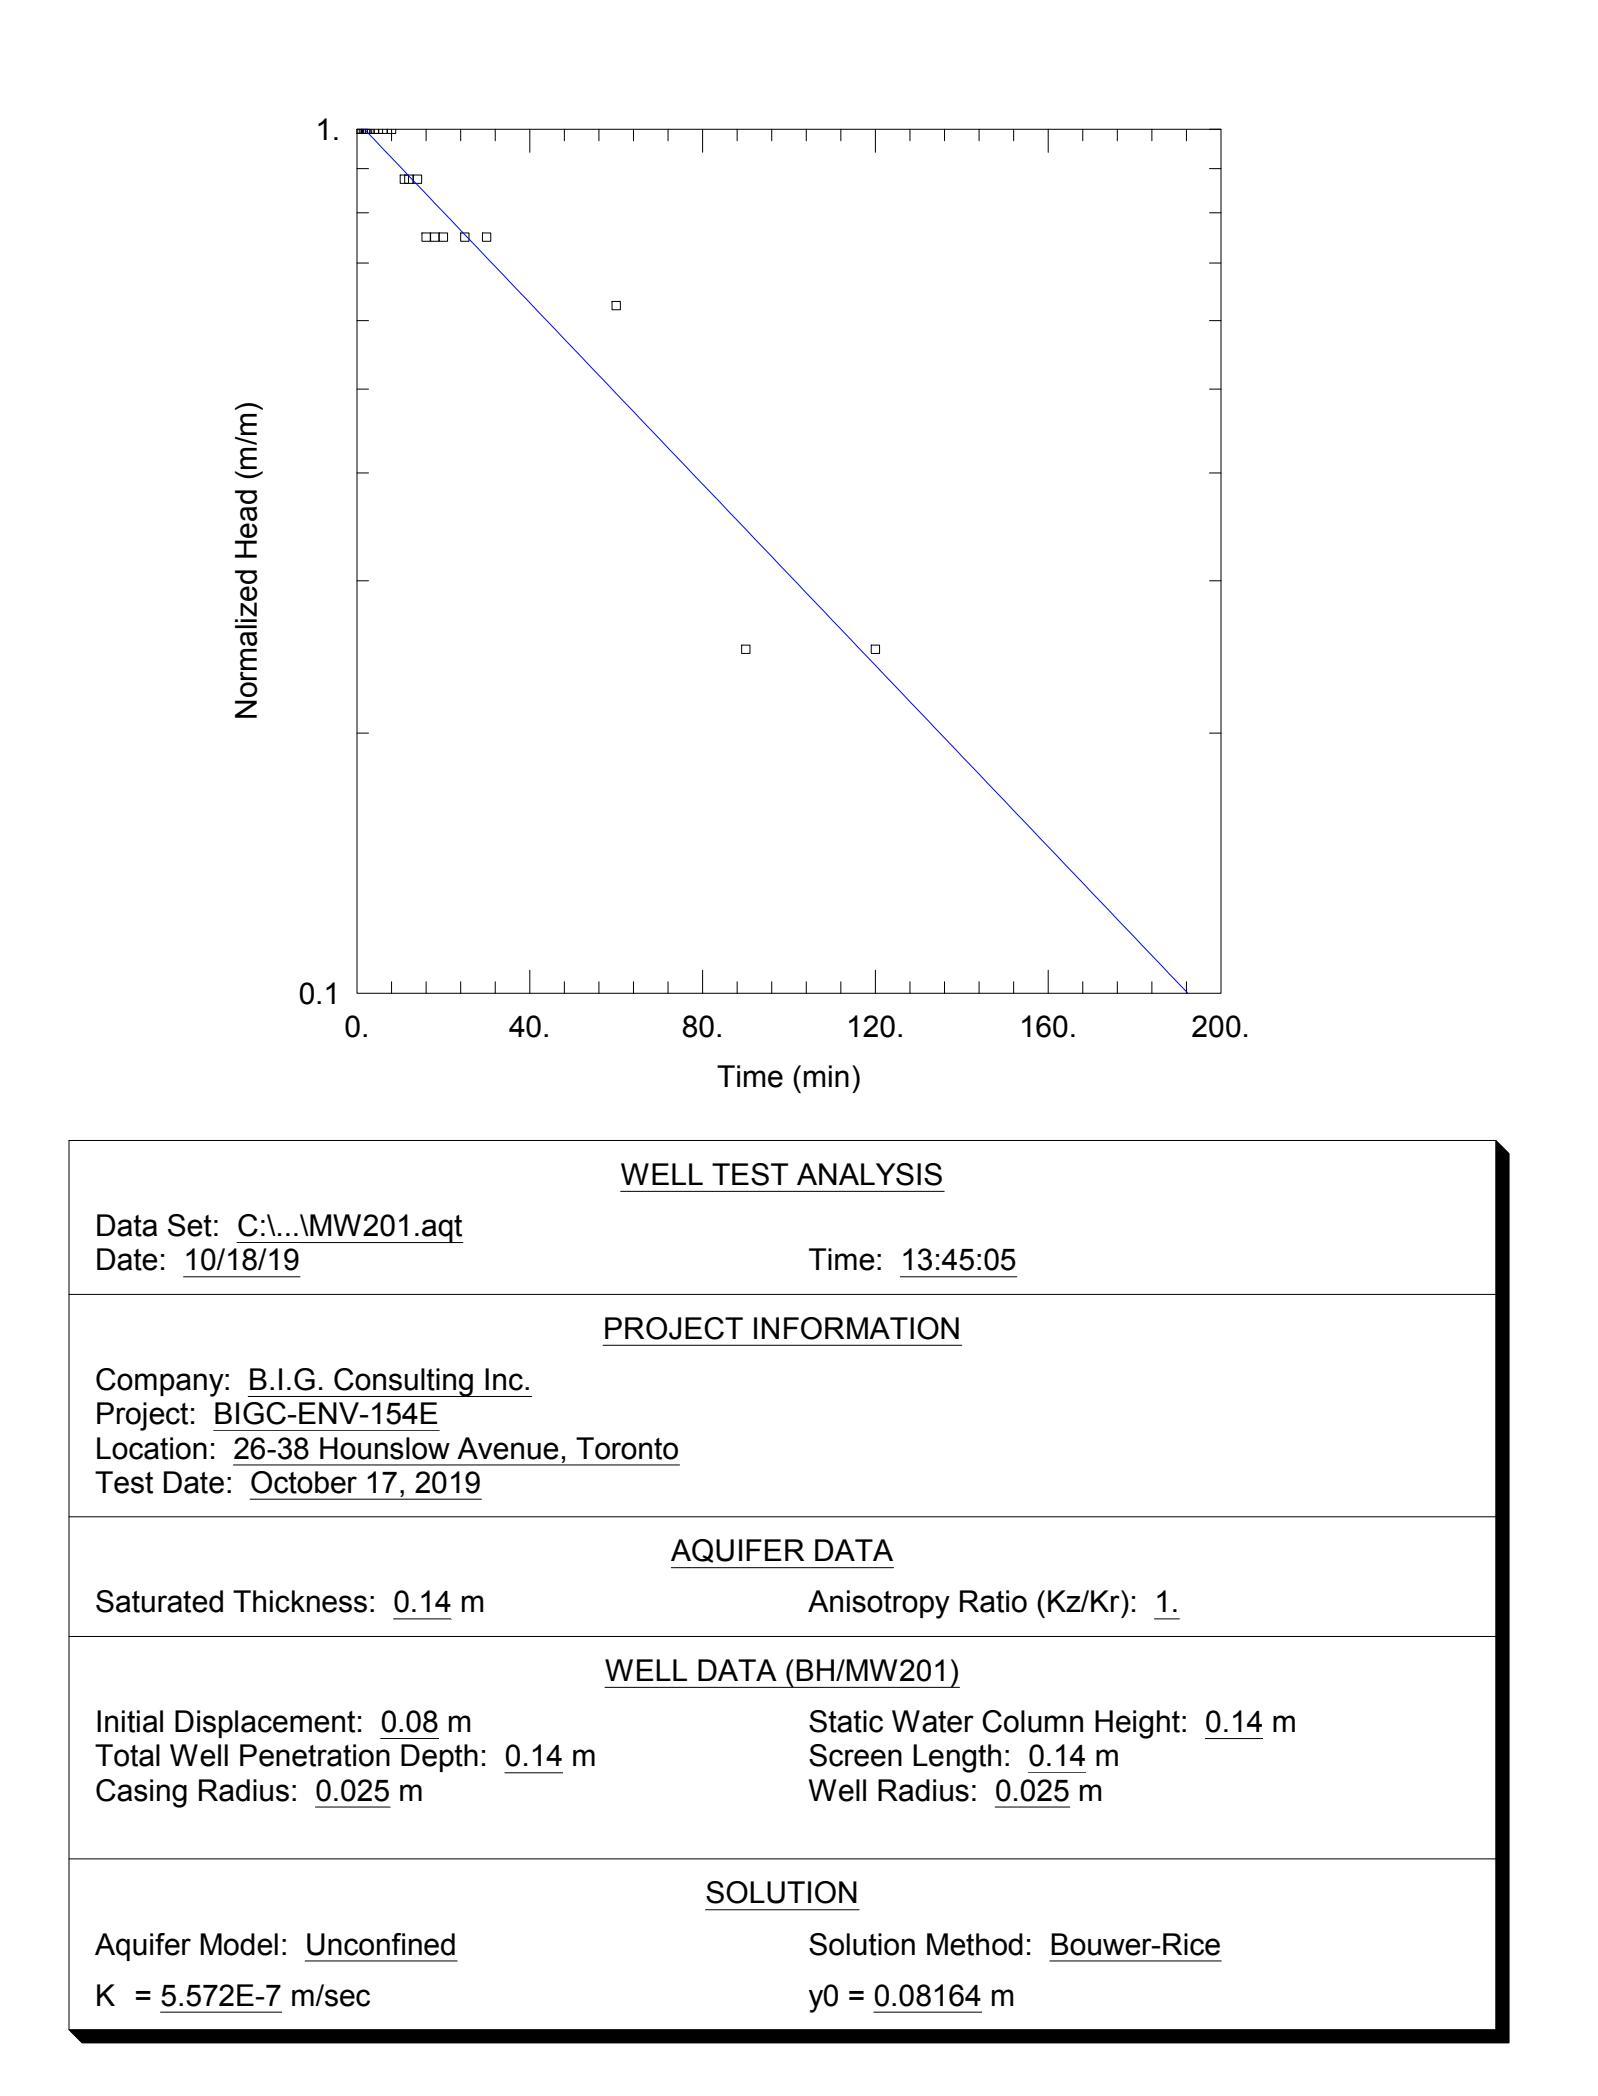
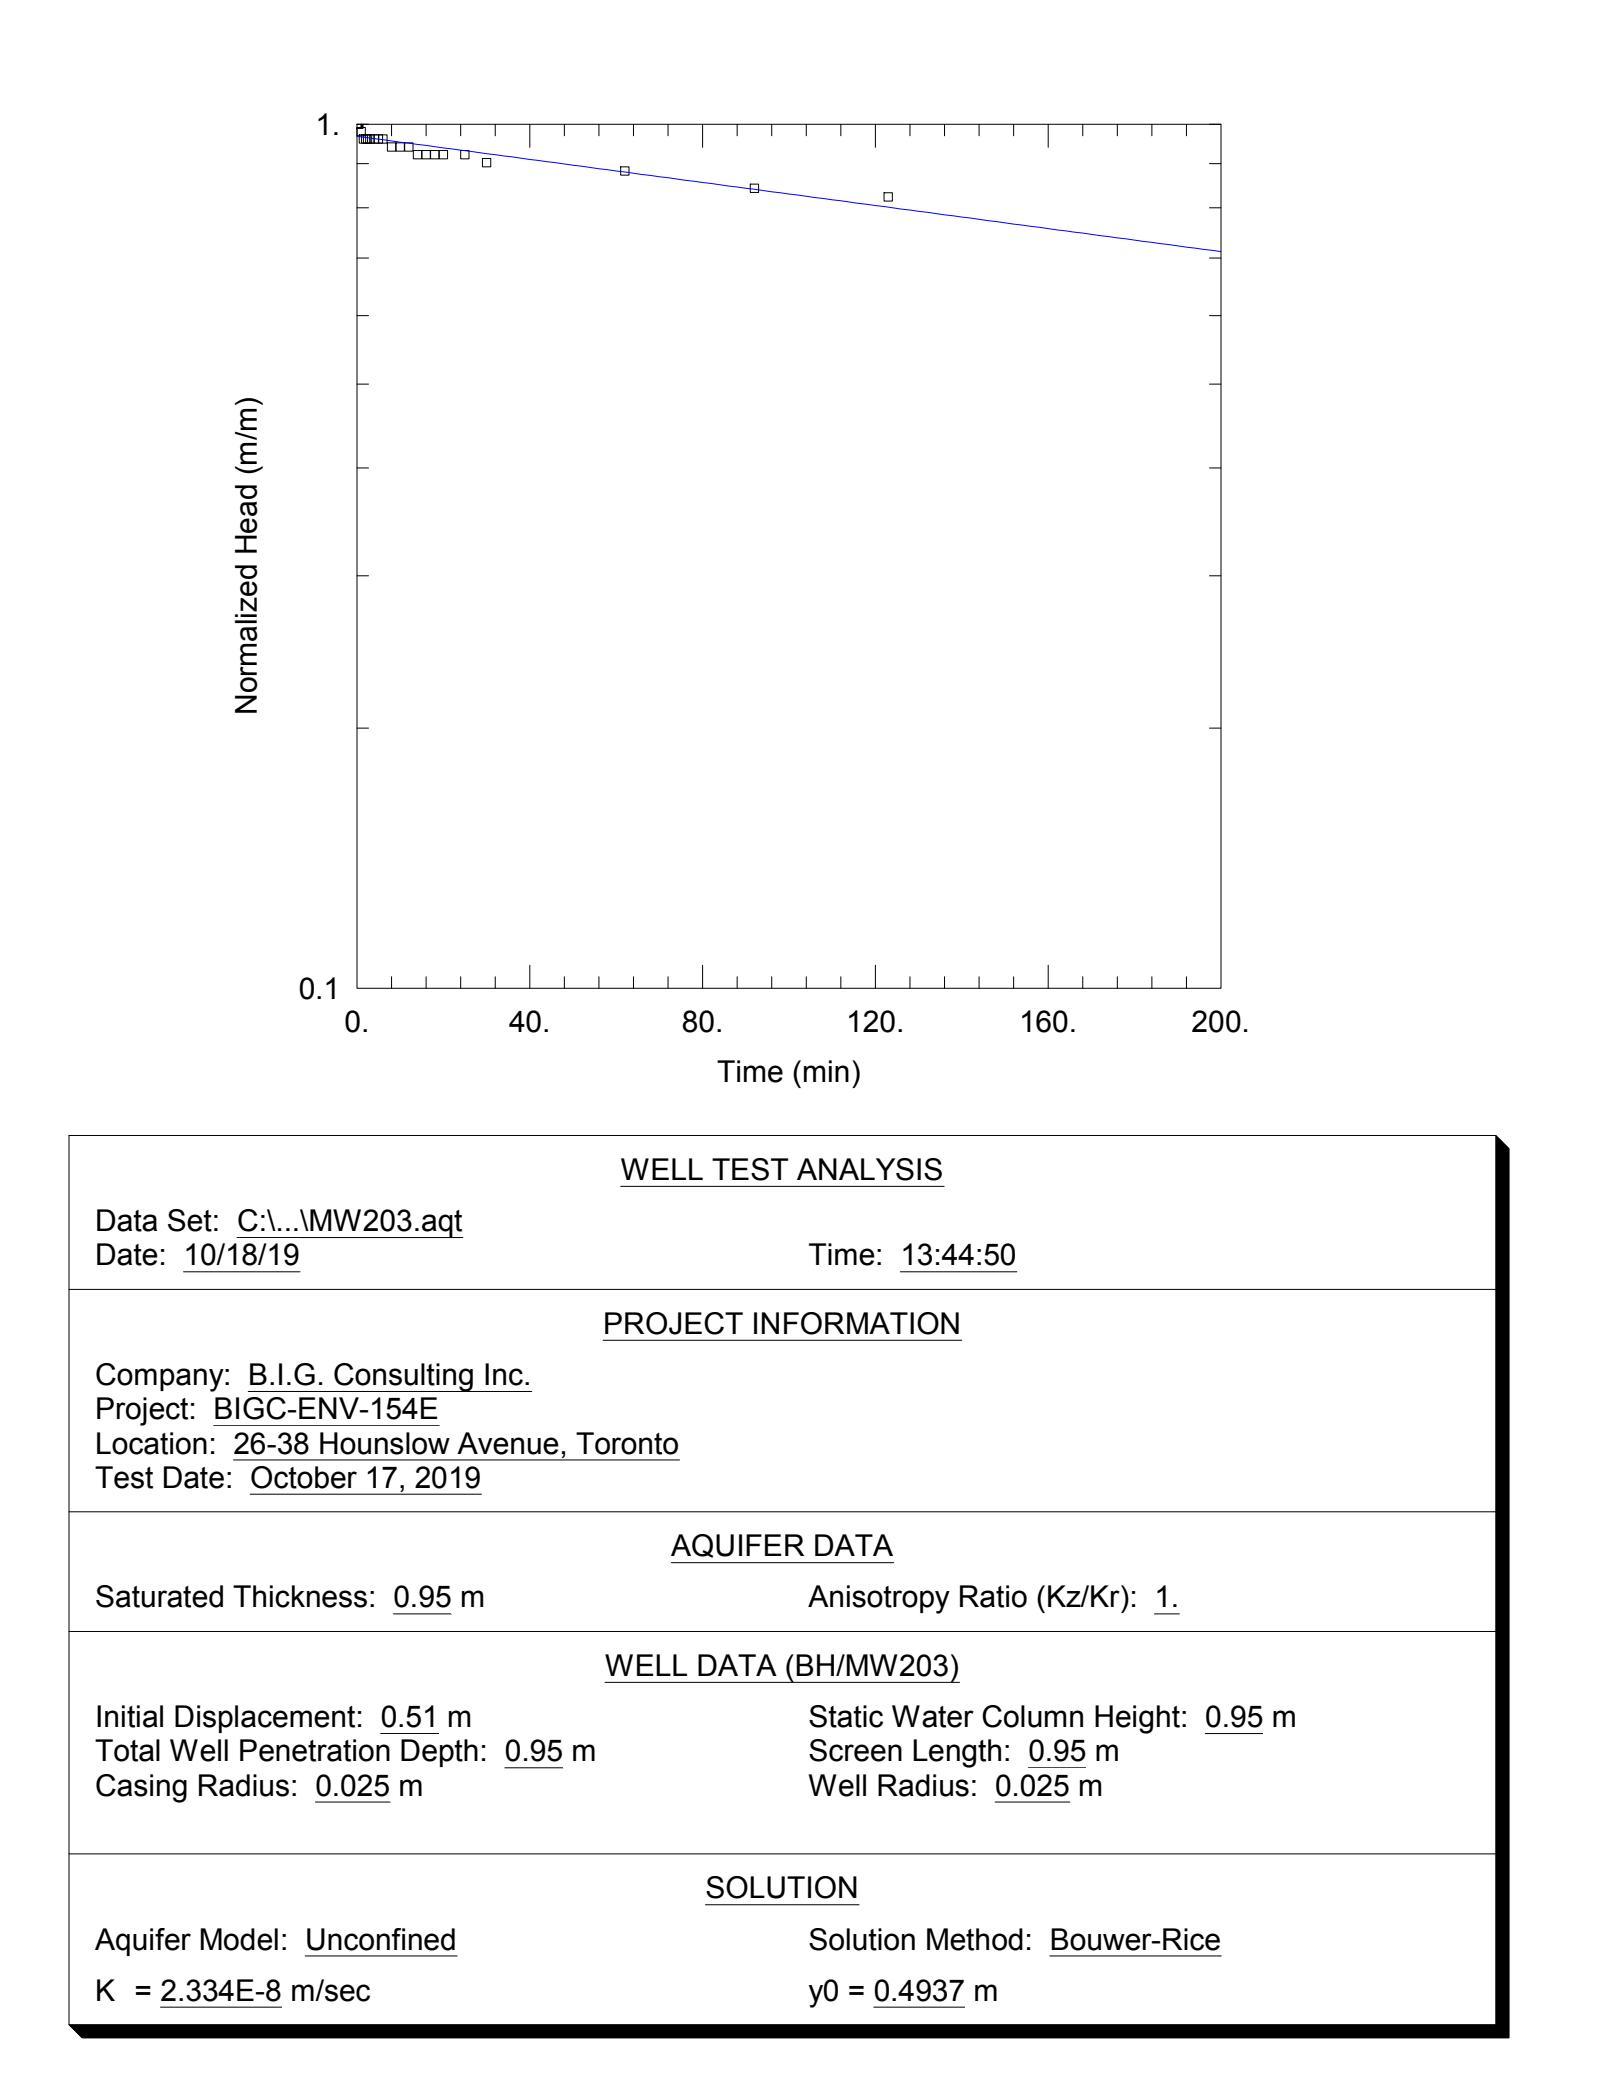
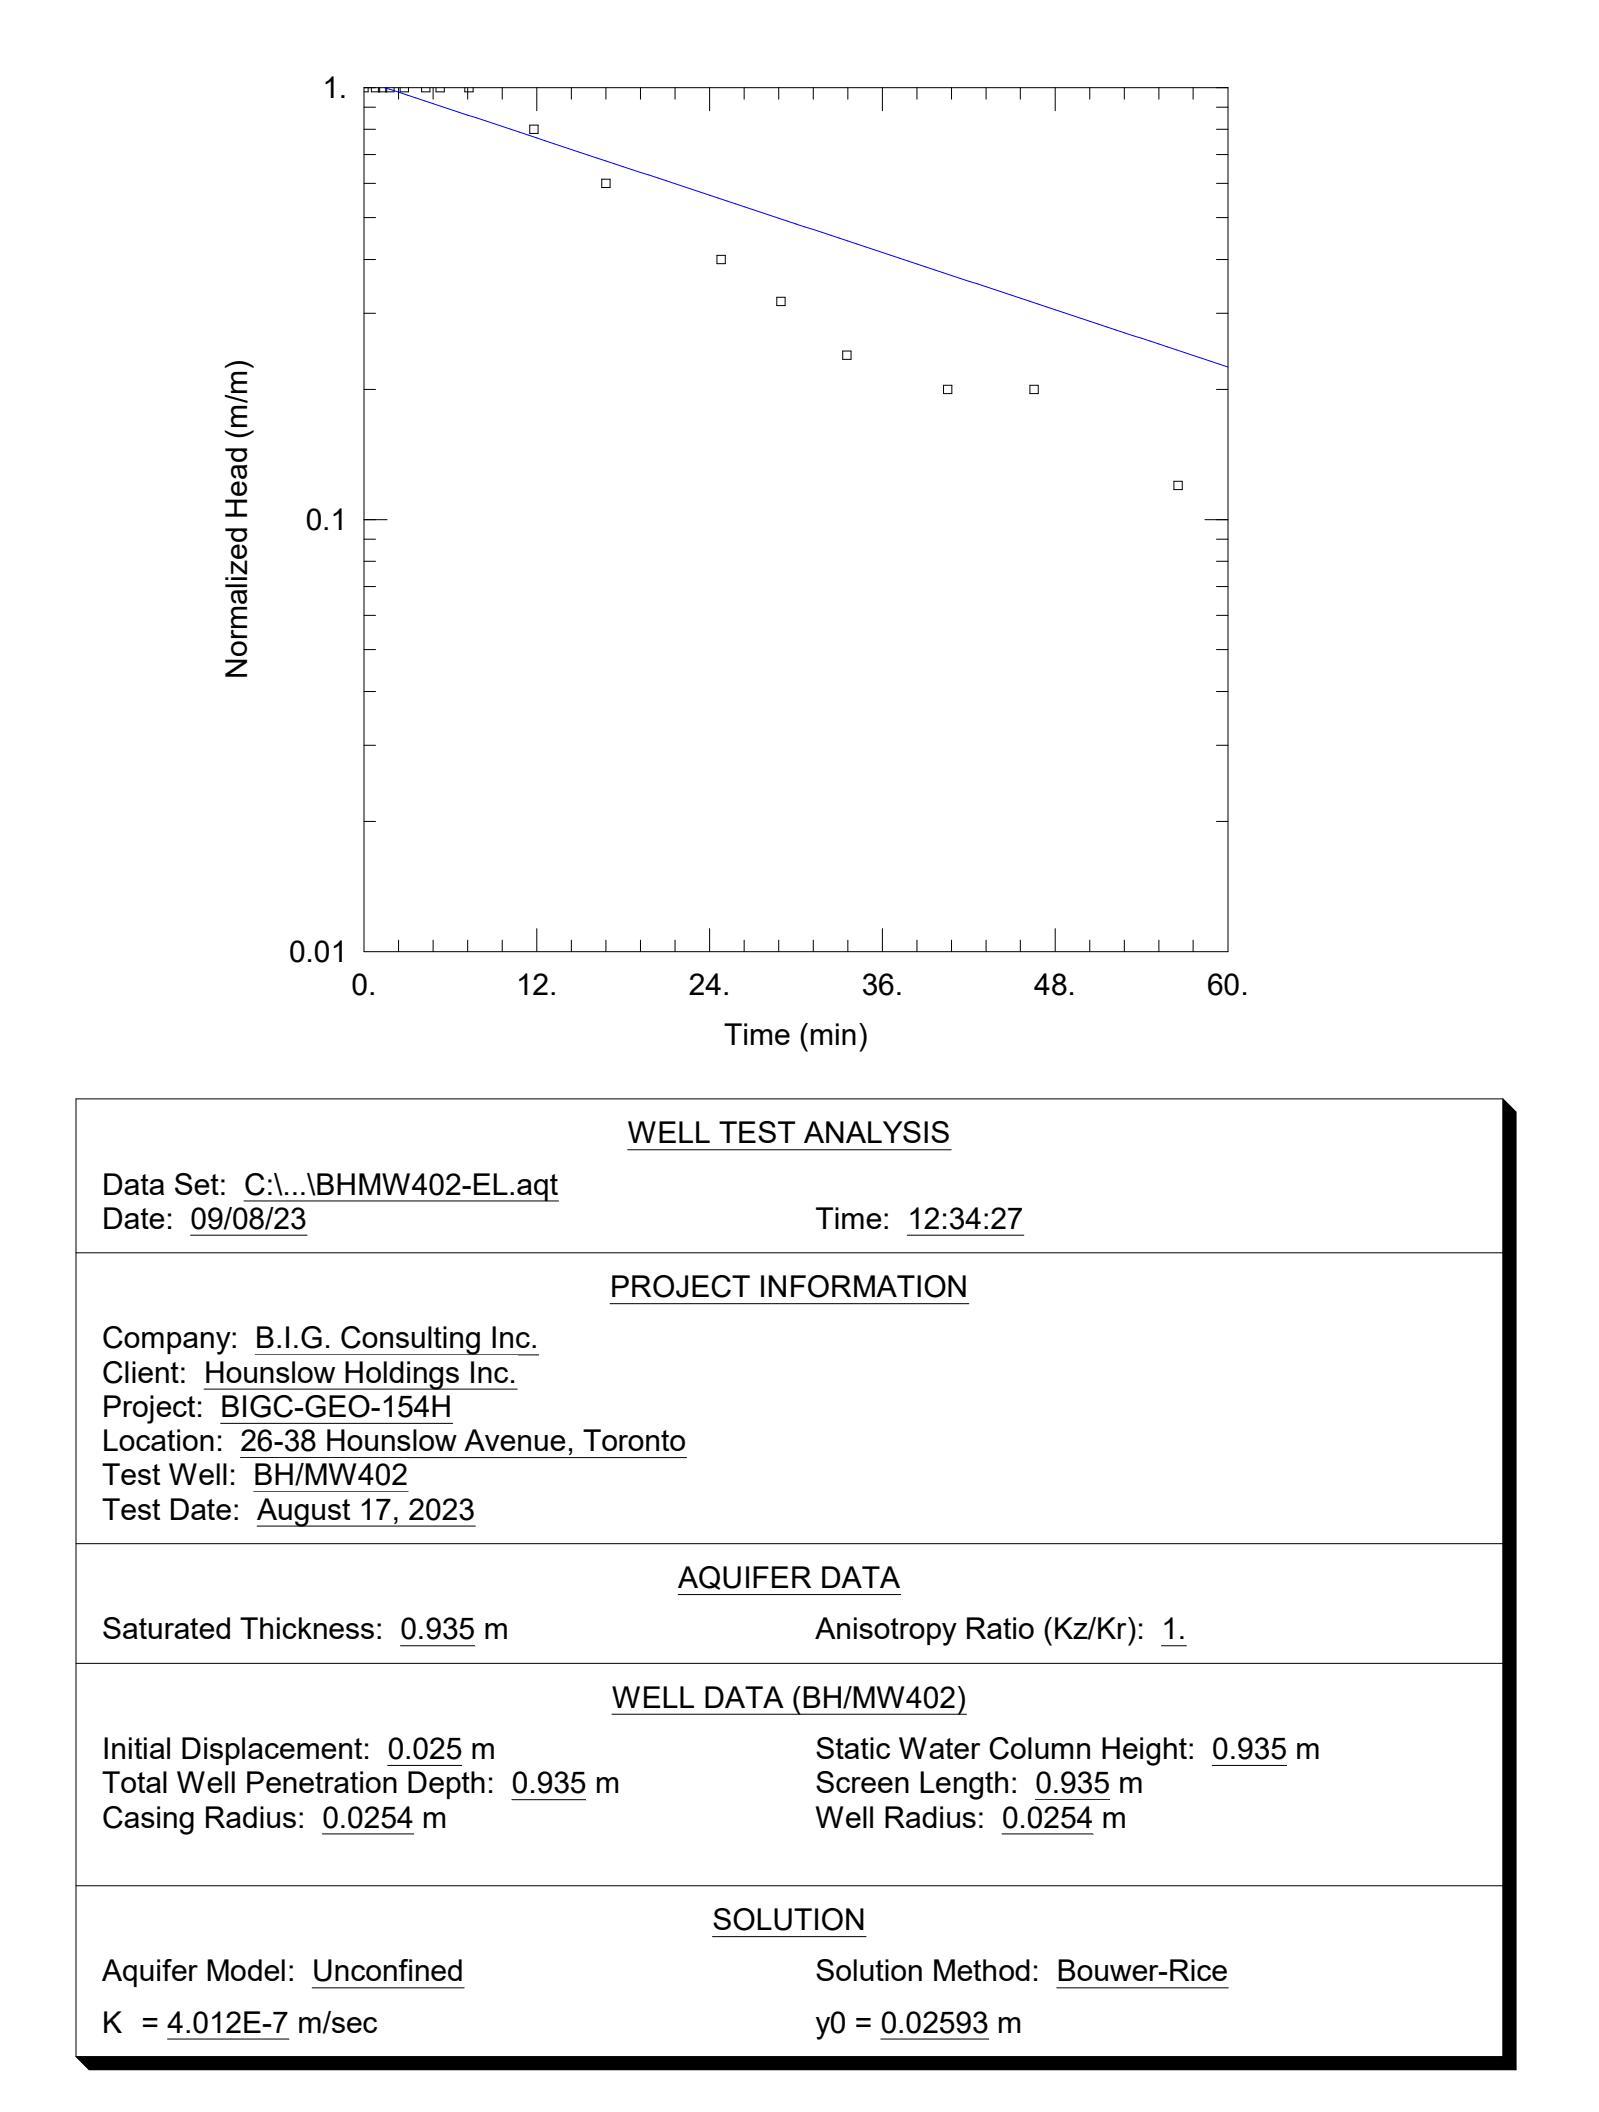
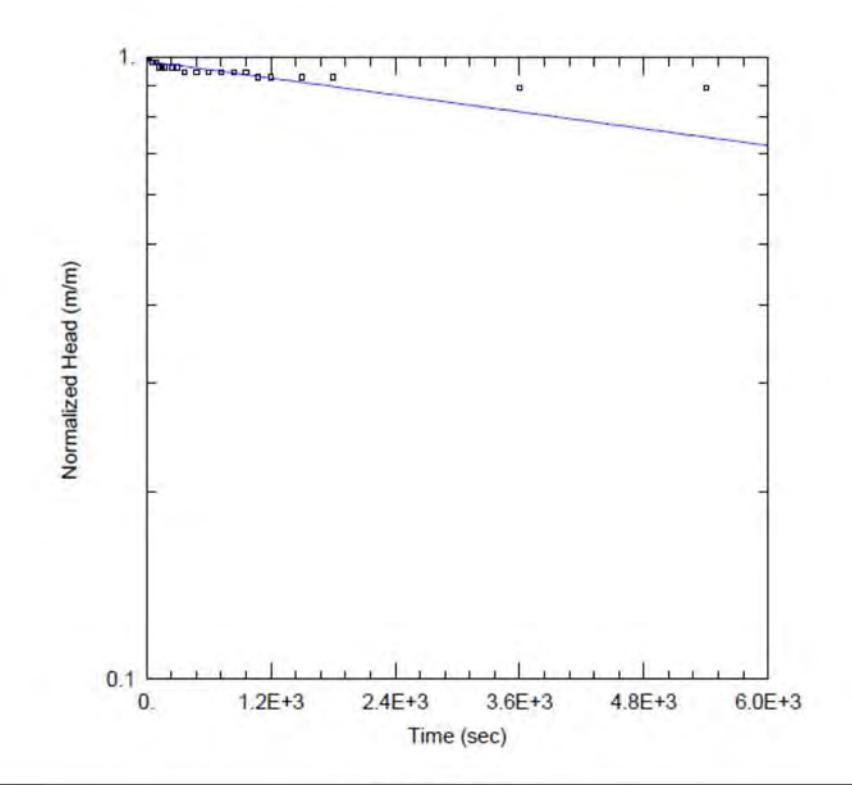
WEL	L TEST ANALYSIS			
WELL TEST ANALYSIS         Data Set: <u>D:\MW101.aqt</u> Date: <u>05/17/17</u> Time: <u>PROJECT INFORMATION</u> Company: <u>Brownfield Investment Group Inc.</u> Client: <u>Mattamy Homes</u> Project: <u>BIG-ENV-154</u> Location: <u>26-36 Hounslow Ave., North York, Toronto</u> Test Date: <u>April 4, 2017</u> <u>AQUIFER DATA</u> Saturated Thickness: <u>0.28</u> m       Anisotropy Ratio (Kz/Kr):         Static Water Column Height: <u>0.28</u> m       Screen Length:         Total Well Penetration Depth: <u>0.28</u> m       Screen Length:         Casing Radius: <u>Ol25</u> m <u>SOLUTION</u>				
PROJ	ECT INFORMATION			
Company: Brownfield Investment Group Inc. C <u>Mattamy Homes</u> Project: <u>BIG-ENV-154</u> Location: <u>26-36 Hounslow Ave., North York, T</u> Test Date: <u>April 4, 2017</u>	Client: Toronto			
A	QUIFER DATA			
Saturated Thickness: 0.28 m	Anisotropy Ratio (Kz/Kr): 1.

WE	LL DATA (MW101)			
Initial Displacement: 0.28 m Total Well Penetration Depth: 0.28 m Casing Radius: 0.025 m	Static Water Column Height: 0.28 m Screen Length: 0.28 m Well Radius: 0.025 m Gravel Pack Porosity: 0.3			
	SOLUTION			
Aquifer Model: Unconfined	Solution Method: Bouwer-Rice			
K = 1.01E-7 m/sec	y0 = <u>0.2759</u> m

During the SWRT, a slug of water was instantaneously removed from the well and the response to the water level was recorded. The hydraulic conductivity values for each of the tested wells were calculated from the SWRT data using Aqtesolv Software and the Bouwer-Rice solution for unconfined conditions. The semi-log plots for normalized drawdown versus time are included in Appendix C.
