HYDROGEOLOGICAL INVESTIGATION

26-38 Hounslow Avenue, Toronto, Ontario, M2N 2A8

BIGC-GEO-154H

September 21, 2023 (Revision 4)

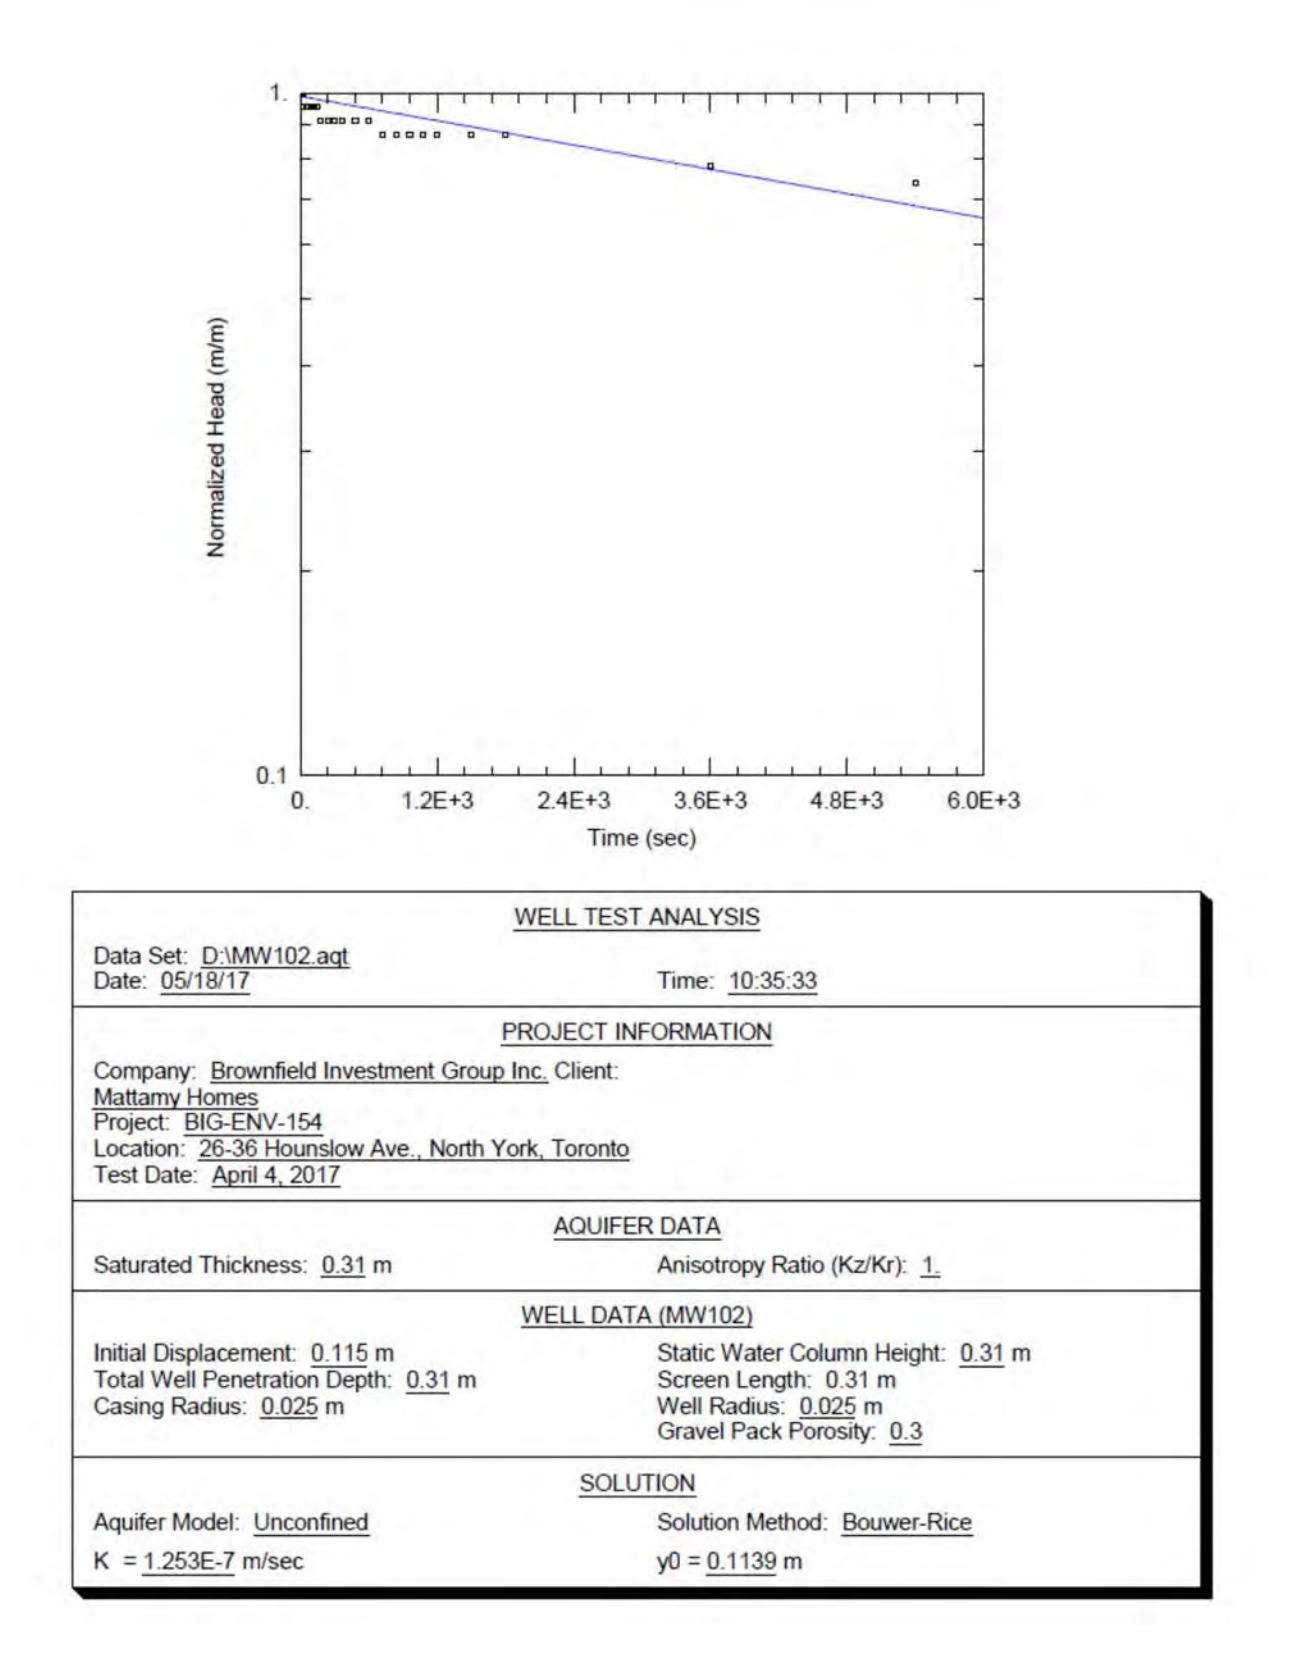
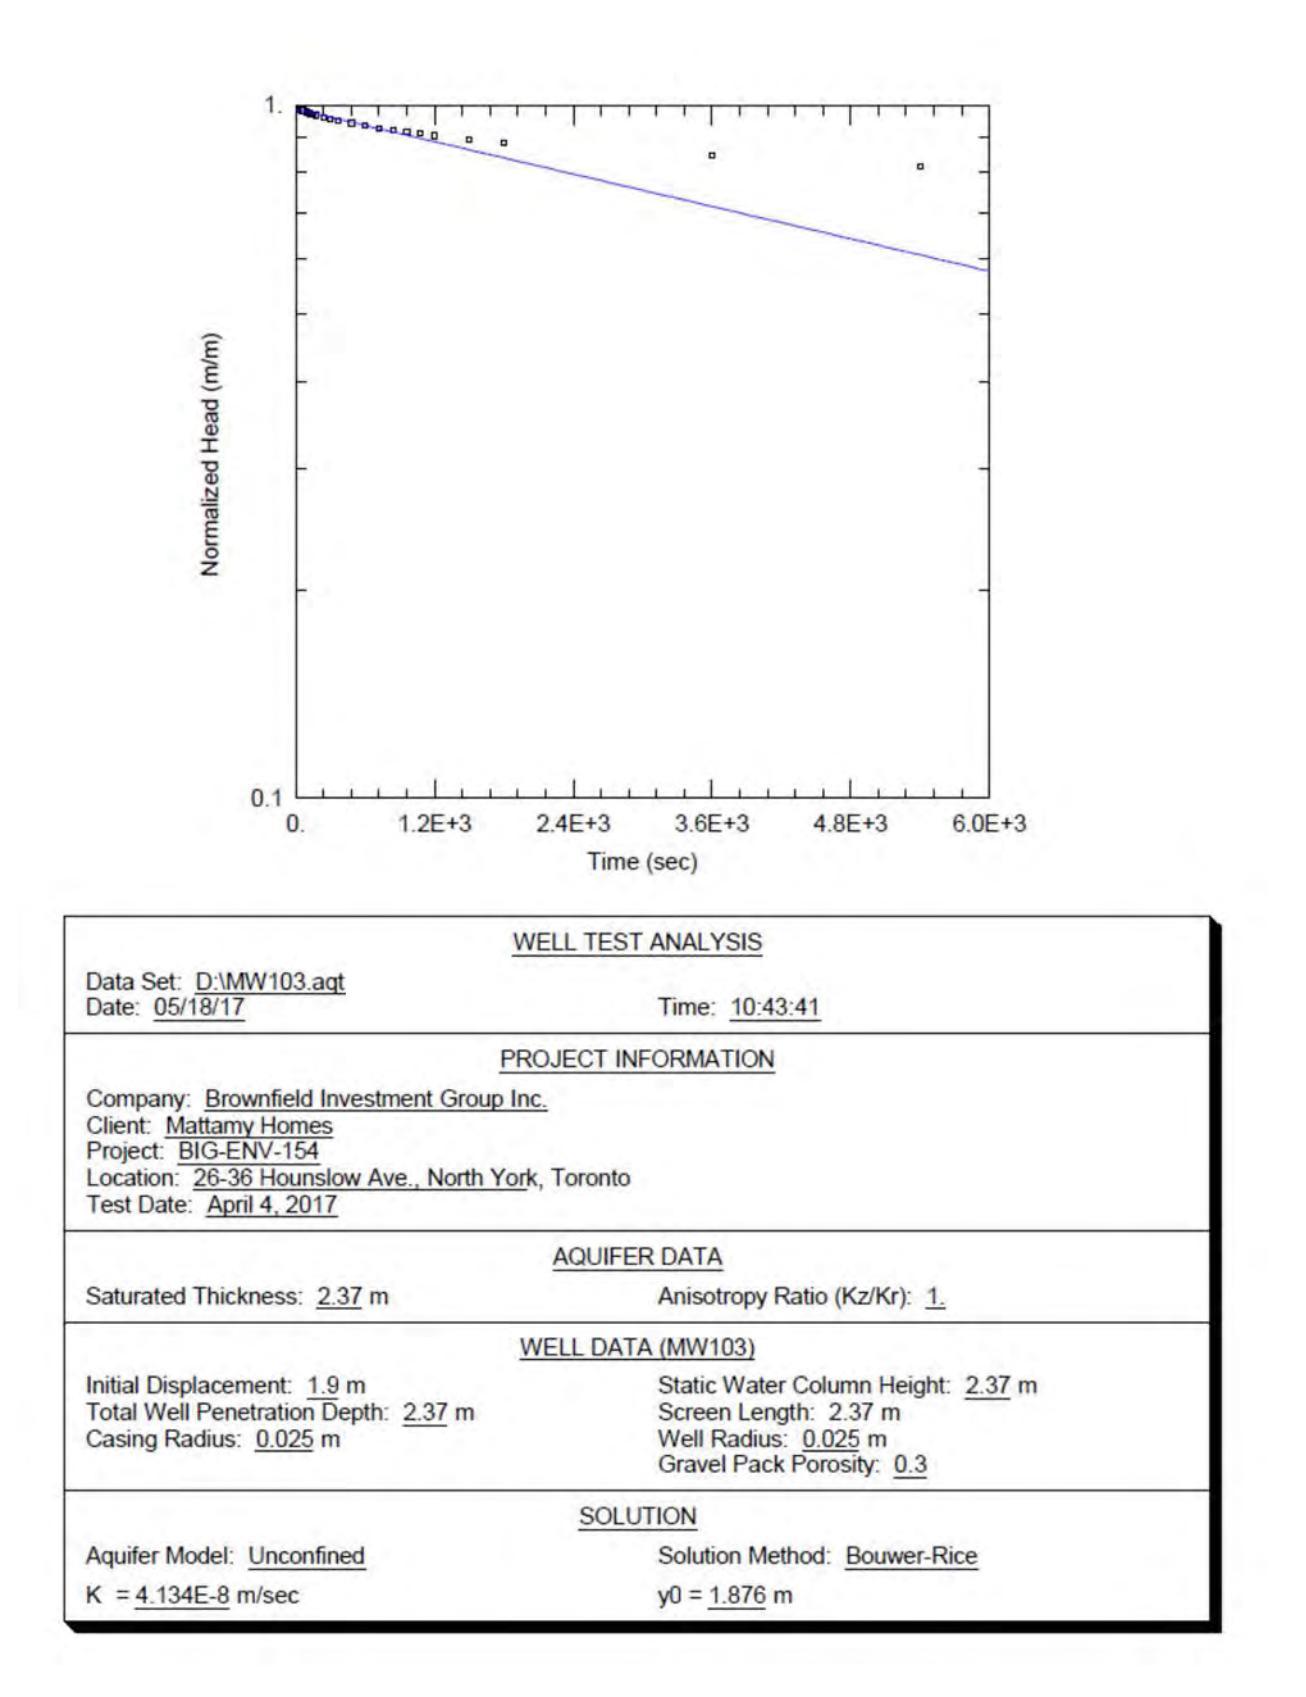
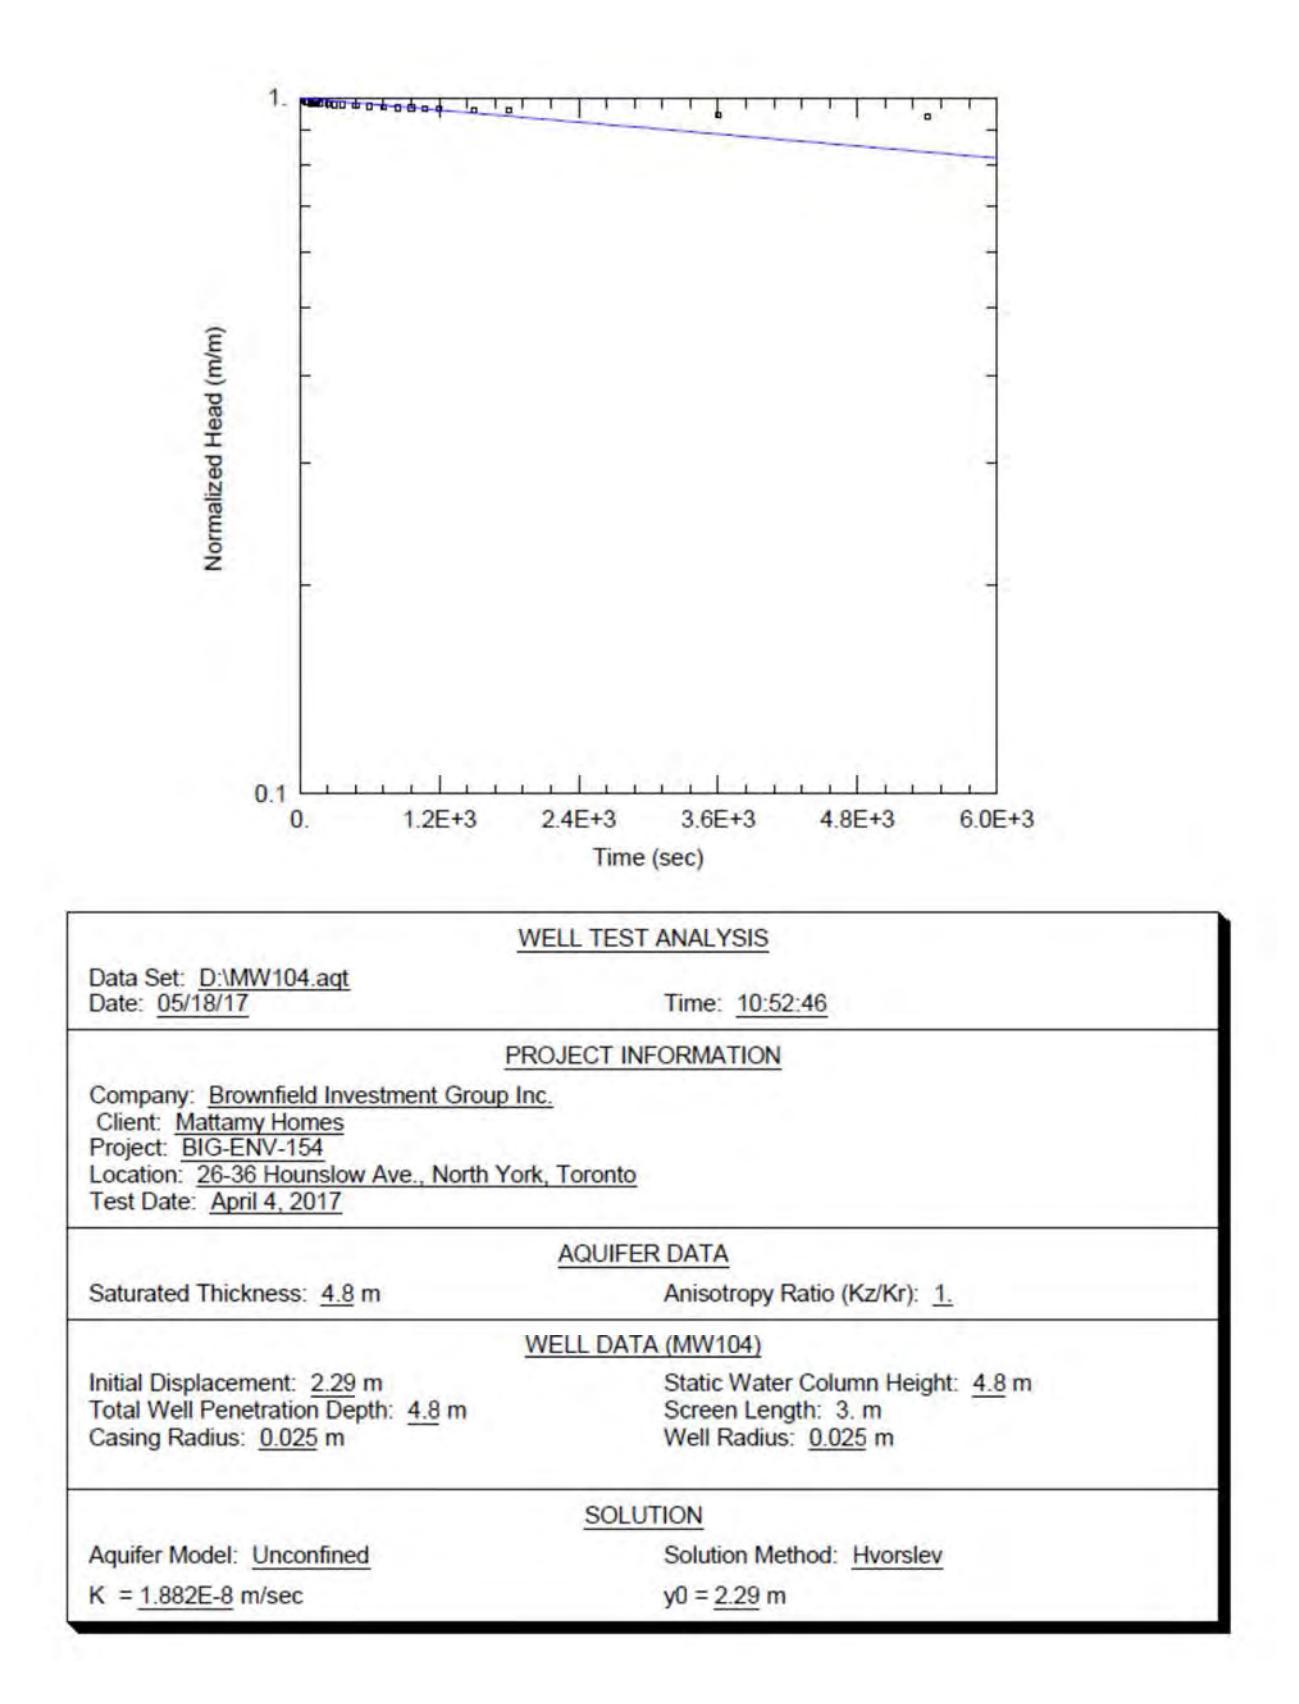
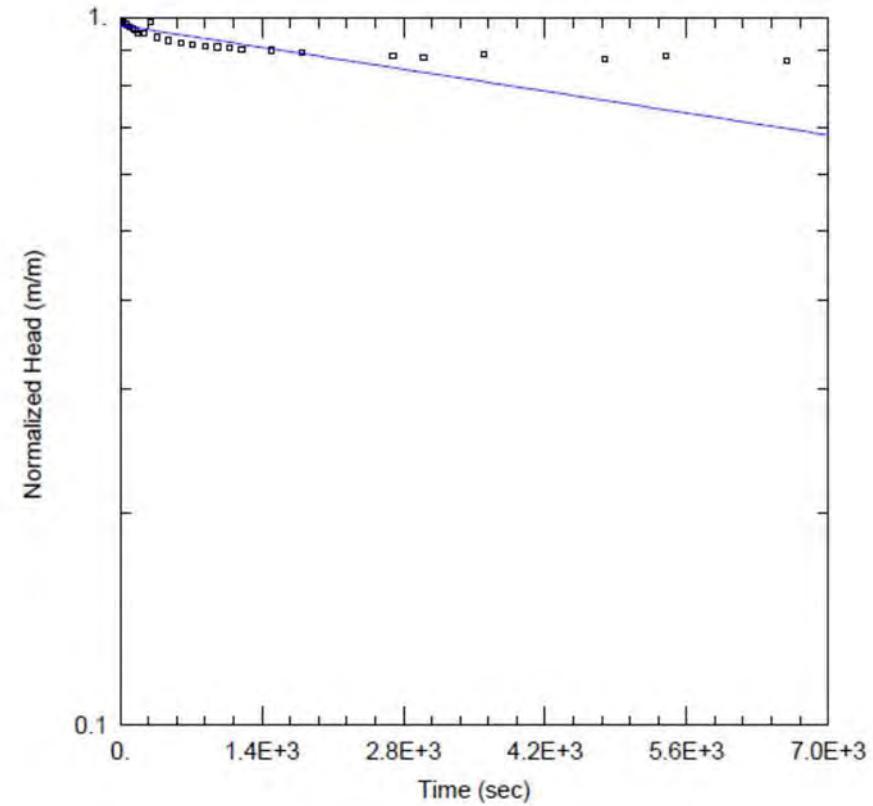
WEL	L TEST ANALYSIS
WELL TEST ANALYSIS         Data Set: D:MW107.aqt       Time: 11:25:26         PROJECT INFORMATION       Company: Brownfield Investment Group Inc.         Client: Mattamy Homes       Project: INFORMATION         Company: Brownfield Investment Group Inc.       Client: Mattamy Homes         Project: BIG-ENV-154       Location: 26-36 Hounslow Ave., North York, Toronto         Test Date: April 4, 2017       AQUIFER DATA         Saturated Thickness: 2.82 m       Anisotropy Ratio (Kz/Kr): 1.         WELL DATA (MW107)       Initial Displacement: 1.6 m         Total Well Penetration Depth: 4.62 m       Screen Length: 2.82 m         Casing Radius: 0.025 m       Well Radius: 0.025 m         Gravel Pack Porosity: 0.3       Solution Method: Bouwer-Rice         K = 2.325 0 m/ms       Solution Method: Bouwer-Rice	
PROJ	ECT INFORMATION
Company: <u>Brownfield Investment Group Inc.</u> Client: <u>Mattamy Homes</u> Project: <u>BIG-ENV-154</u> Location: <u>26-36 Hounslow Ave., North York, T</u> Test Date: <u>April 4, 2017</u>	oronto

During the SWRT, a slug of water was instantaneously removed from the well and the response to the water level was recorded. The hydraulic conductivity values for each of the tested wells were calculated from the SWRT data using Aqtesolv Software and the Bouwer-Rice solution for unconfined conditions. The semi-log plots for normalized drawdown versus time are included in Appendix C.
